Landslide at Govindghat – Investigation and stabilization measures

Abstract. A cloudburst and flash flood in June 2013 in the state of Uttarakhand, India caused landslide at Govindghat located along a major highway. Large boulders in soil matrix were encountered in the area. Water seeping through the open pores between the boulders and erosion of the soil were the major causes of the slope-failure. Erosion of the accumulated debris on the valley side during periods of high discharge in the area also added to the instability. The stabilization measures adopted include a secured drapery of rock anchors and steel mesh on the hill side, nailed gabions at road level, reinforced soil wall to ensure the desired road width and river-side gabion wall for erosion protection.

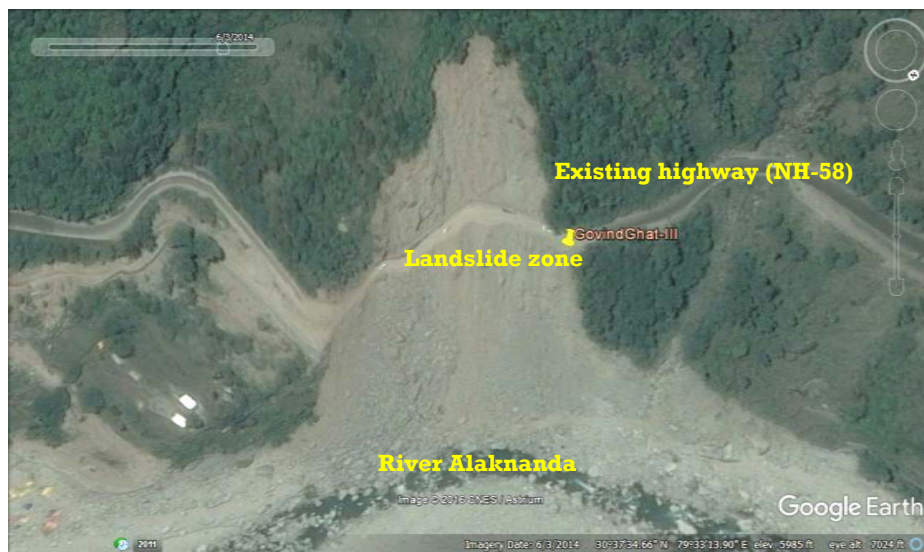
A satellite image in 2012 shows no landslide and overall stable conditions along the highway with vegetation on the hill-slopes (See Fig.1). Satellite image of 2014 illustrated in Fig. 2 shows a major landslide along the highway. Since this is the third landslide in the vicinity of Govindghat town, it is identified as Govindghat III.

Fig. 2. Satellite image in 2014 shows major landslide above and below the highway

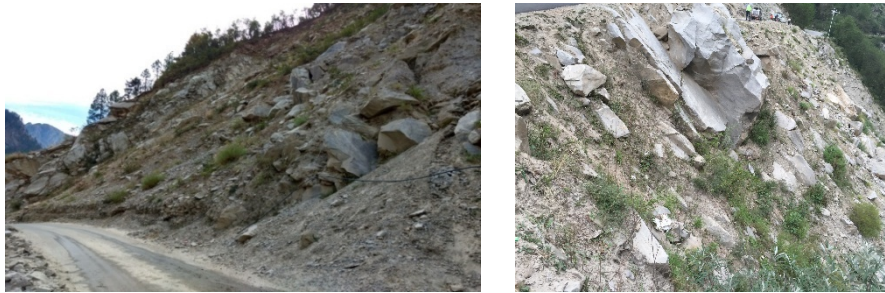
In the landslide area, rocks are not exposed except as a soil-boulder matrix. The boulders are angular and vary in size from less than 0.5 m to 5 m. These boulders are cemented in a sandy matrix. Fig. 3 presents photographs of the area.

Fig. 3. Slopes adjoining the highway at Govindghat with boulder-soil matrix. The photo on the left shows strata above road level and the one on the right shows the strata below road level

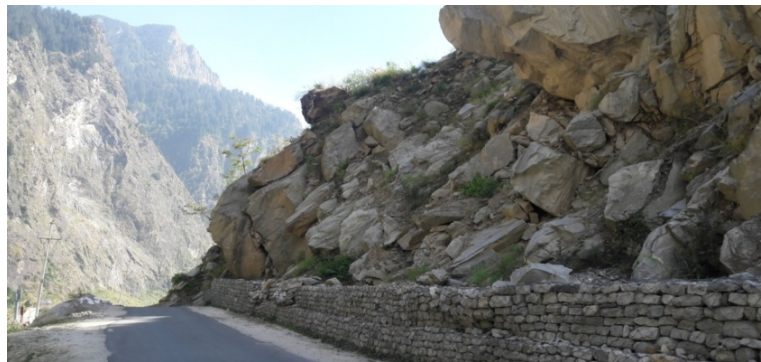
In a 42 m stretch between Chainage km 499+988 to 500+030, large boulders ranging in size from 1 m to 5 m are seen (See Fig. 7). There is substantial fine material between the large pores that tend to get washed away as rainwater percolates through

them. This makes the boulders prone to sliding. Pore-water pressure builds up due to the water percolation which in turn triggers rockfall. The damage to the non-engineered hand-made gabion wall at the toe of the slope highlights the problem.

Fig. 7. Stretch with large boulders and open pores. Note the damage to the non-engineered handmade gabion wall

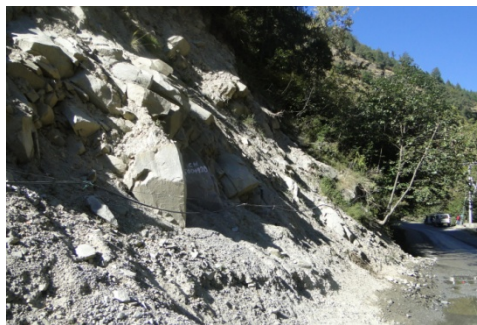
In this stretch, the the material on the hillslope consists of loose overburden soil and fractured rock (See Fig. 8). The fines get eroded due to seepage during heavy rains and this triggers the landslide. Consequently, the soil debris causes water-logging of the road as illustrated on Fig. 9.

Fig. 8. Loose soil with boulders

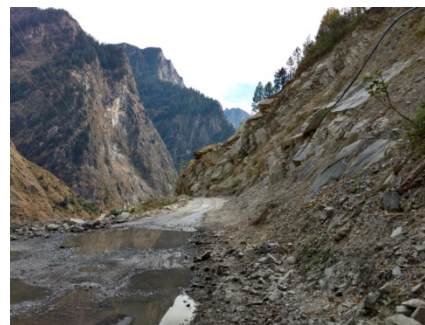
Fig. 9. Water and debris accumulated on road

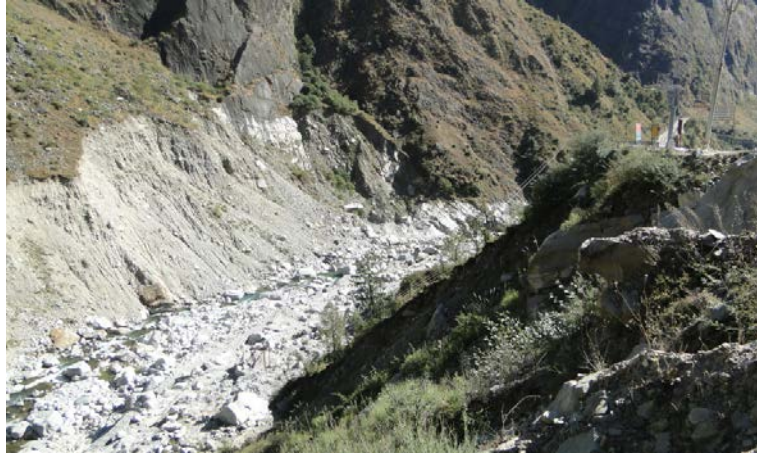
Erosion of the toe along the Alaknanda River at Govindghat is also one of the causes of landslides in the area. The loose alluvium accumulated on the toe of the river gets eroded, particularly during floods and periods of high discharge during monsoons. This increases the instability, thereby creating conditions favorable for a landslide. The impact of toe erosion is illustrated in Fig. 10.

Fig. 10. Toe erosion on valley side

5. For protecting the toe exposed to the river, a gabion toe-wall has been provided for the whole 150m stretch along with the gabion mattress as launching apron to protect the exposed toe and reduce erosion as per IRC 89 [7]. The mattress was covered with big boulders (min. 800 mm size). The gabion mattress act as a launching apron and boulders provided added protection against large boulder impacts to the structure flowing along the river during floods. The protection has been done to 1
