# IN-SITU TESTING TO VERIFY GROUND IMPROVEMENT

Ravi Sundaram

Cengrs Geotechnica Pvt. Ltd., India

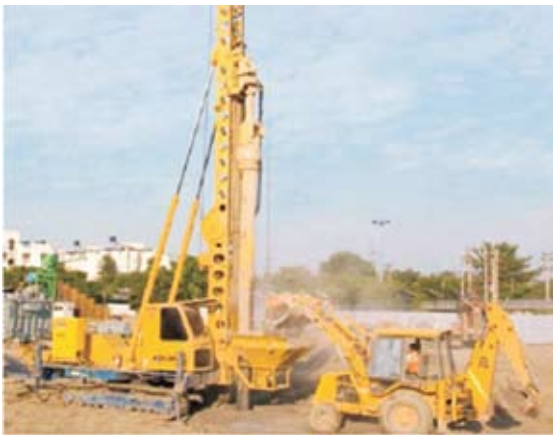
Fig. 7: Vibro-Replacement in progress

Dry vibro-stone columns of 500 mm-diameter with center to center spacing of 1.5 m were installed in these areas to 10 m depth by bottom feed method, as shown on Fig. 7. The stone columns were designed for a safe net bearing pressure of 160 kPa.

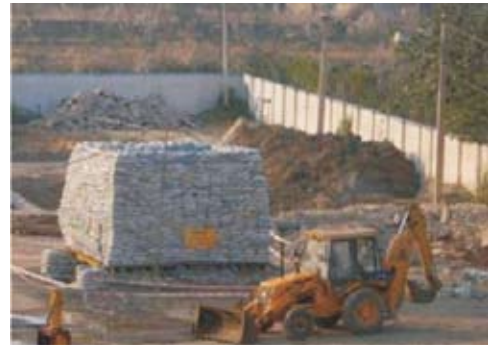
Fig. 9: Load Test on Stone column

To assess the load-settlement characteristics of the improved ground, load tests were performed on the stone columns. A 300 mm thick compacted sand pad was placed over the stone columns. A 30 mm thick, 1.5 m x 1.5 m square test plate with steel stiffeners was placed over the sand pad (Fig. 9).

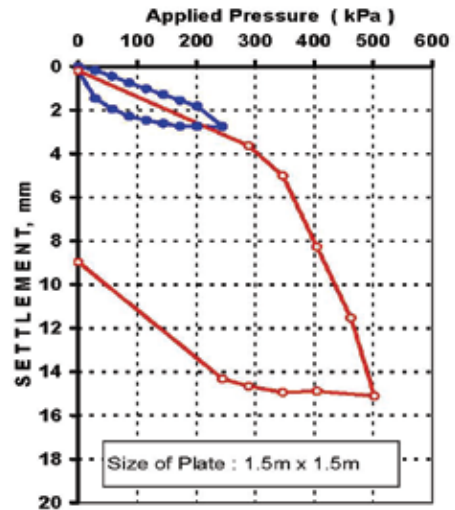
Fig. 10: Results of Load Test on Stone Column

The single column load test was performed up to a loading intensity of 240 kPa in the first loading cycle, and 500 kPa in the second cycle. The test results are presented on Fig. 10. Based on the test results, the authors' concluded that foundations bearing on the improved ground are safe for the design bearing pressure of 160 kPa.

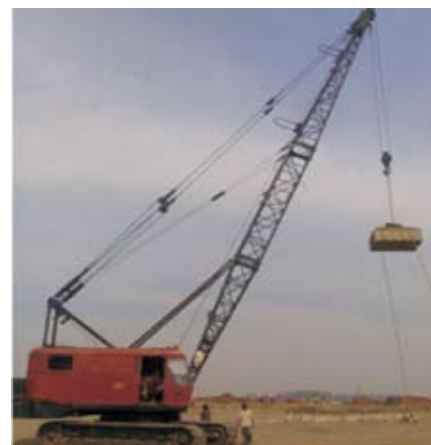
Fig. 14: Dynamic Compaction in progress on site

Out of the various methods available for densification of cohesionless soils, dynamic compaction was adopted at the project site. Initial field trials were carried out in the university areas, which demonstrated substantial improvement. Figure 14 shows the conventional crane (TLC 955A) and the pouncer used for performing the dynamic compaction.

At the Boys Hostel building site, the contractor used a 114.3 kN pouncer falling from a height of 14 m. The dynamic compaction was done in two phases, followed by an ironing phase. Details are explained below:
