# BACK-ANALYSIS OF PILE LOAD TEST RESULTS – A CASE STUDY

Ravi Sundaram, Sorabh Gupta

Cengrs Geotechnica Pvt. Ltd., A-100, Sector 63, Noida Fax: 0120-4206775 email: [cengrs@gmail.com](mailto:cengrs@gmail.com)

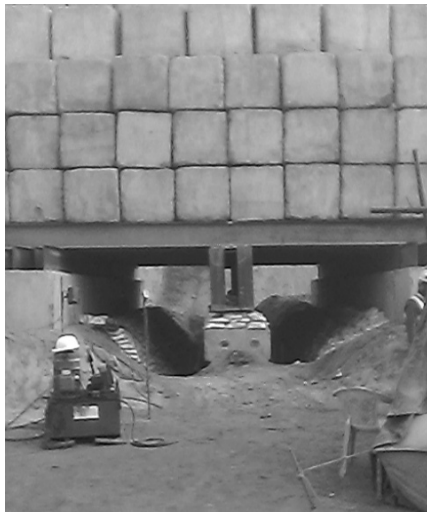
Fig. 2: Load Test Set-up

A photograph of the load test set up is presented on Fig. 2. The test results are plotted on Fig. 3.

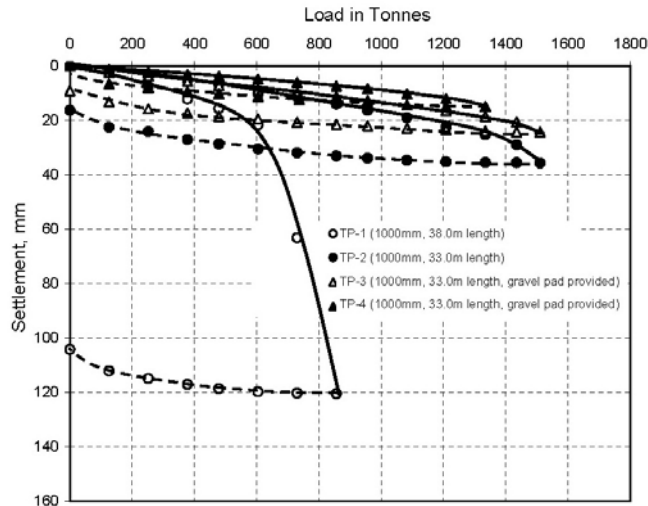
Fig. 4: Load-settlement Curves – 1000 mm diameter piles

The test results are plotted on Fig. 4.

The pile load test results are fairly inconsistent / scattered. There is no clear trend in the pile performance with increasing pile diameters and length. Many piles (especially TP-1, 2 & 3 of 1200 mm diameter piles; and TP-1 of 1000 mm diameter) seem to have significantly underperformed on site, indicating possible structural defects in the pile and / or poor bottom cleaning. Considering the poor performance of the 1200 mm diameter, the builder decided not to use 1200 mm diameter piles.

On the contrary, some of the piles (such as TP-2, 3 & 4 of 1000 mm diameter) performed rather well, and indicate interpreted safe pile capacities significantly in excess of the anticipated theoretical capacities. Therefore, it was

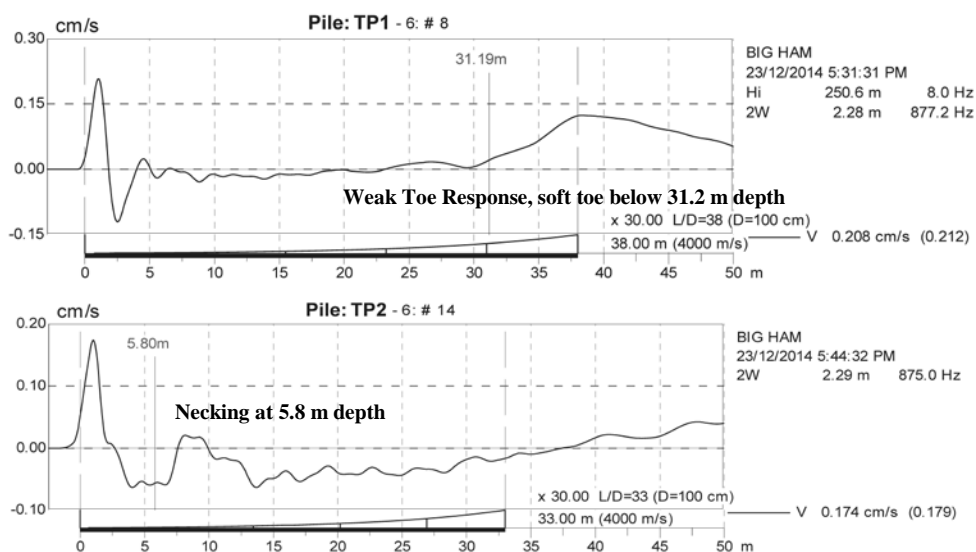
**Fig. 5: Typical Results – Low-Strain Pile Integrity Tests on 1000 mm diameter piles**

Low strain integrity tests were performed on all the test piles. Typical test results for two of the 1000 mm diameter piles are presented in Fig. 5.

Pile No.	Pile Length below test level, m	Comments on PIT Results	Test Conclusion
TP1	38	Reduction of pile impedance below about 30-31m depth. This could indicate reduction in pile cross-section, weak concrete or "soft toe" condition below this depth. Might explain the ' <i>plunging behaviour</i> ' observed during the static load test	Pile integrity is OK to about 30-31m depth. " <i>Soft Toe</i> " condition suspected at about 30-31m depth.
TP2	33	Minor reduction in pile impedance (probably necking) at about 5-6m depth	Pile length and integrity are OK.
TP3	33	Pile shaft seems fairly uniform	Pile length and integrity are OK.
TP4	33	Increase in pile impedance (possibly bulging) between 15m and 25m depths, followed by a return to nominal diameter	Pile length and integrity are OK.

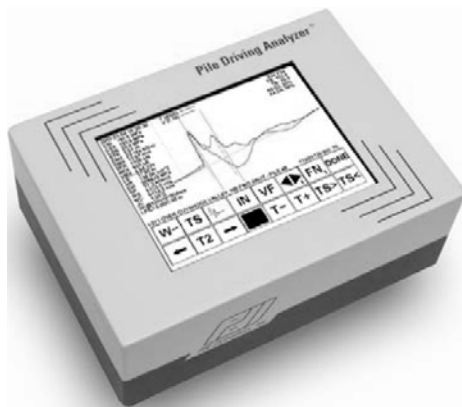
**Fig. 6. Pile Driving Analyzer (PDA)**

The signals of strain and acceleration were conditioned and processed by a Pile Driving Analyzer (PDA) illustrated on Fig 6. Dynamic testing on the pile was conducted by striking the piles by several blows during the re-striking process as shown in Fig.7. Complete dynamic measurements were obtained for each hammer blow delivered to the pile. The PDA investigates driving stresses, pile integrity, hammer performance, and bearing capacity.

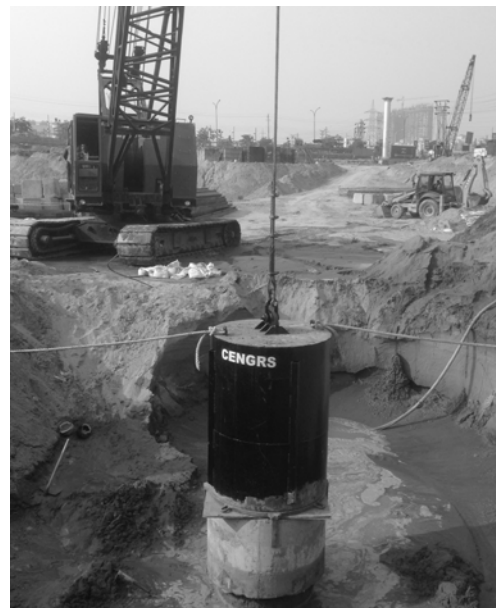
**Fig. 7. Hammer Impact on Pile**

For a better assessment of the pile behaviour, a dynamic pile load test was performed on TP-3 in accordance with ASTM D4945-12. Four strain transducers and two accelerometers were attached to the pile head. They were mounted on opposite sides of the pile for cancellation of bending effects during each strike of the hammer. A 5.1 tonne hammer falling through heights varying from 0.5 to 2.5 m was used to conduct the test.
