Geotechnics of a Unique Irregular High-Rise Statue

Abstract. Construction of a 107 m (351 ft) high Shiva statue on a hillock at Nathdwara, Rajasthan posed several challenges both geotechnical and structural. Detailed geotechnical investigation showed the presence of quartzite rock from the ground surface that is highly fractured at shallow depths and improves in quality with increasing depth. Rock anchors were provided for stability against wind and earthquake loading. The slopes in the surrounding areas were stabilized effectively by suitable measures. The structure details and other aspects of the elegant monument are described.

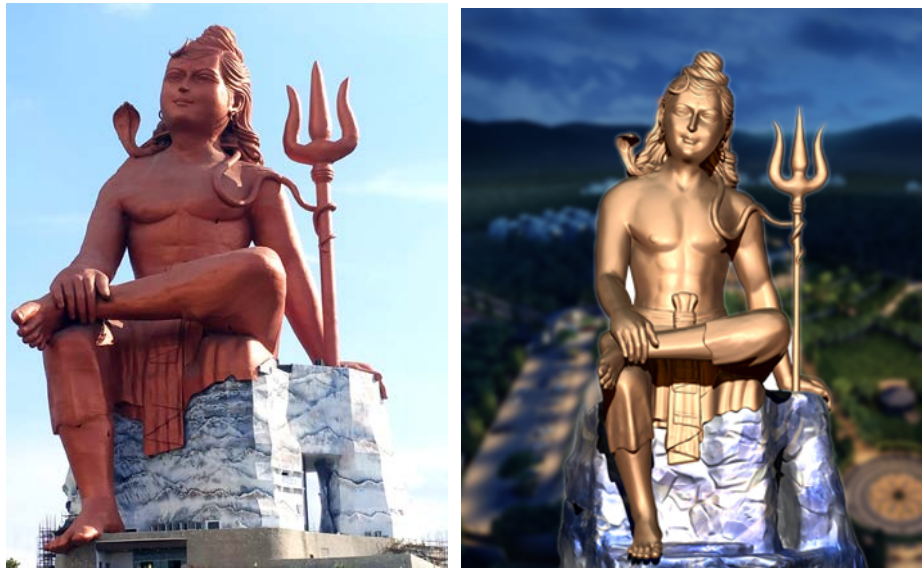
Fig. 1. Photograph (left) of the 107 m (351 ft) high statue shows Lord Shiva in sitting pose with trishul by the side. Photo on the right is the sculptor's imagination (model)

Fig. 1 presents a photograph of the statue [2] showing Lord Shiva in a pleasing appearance and the artist's impression.

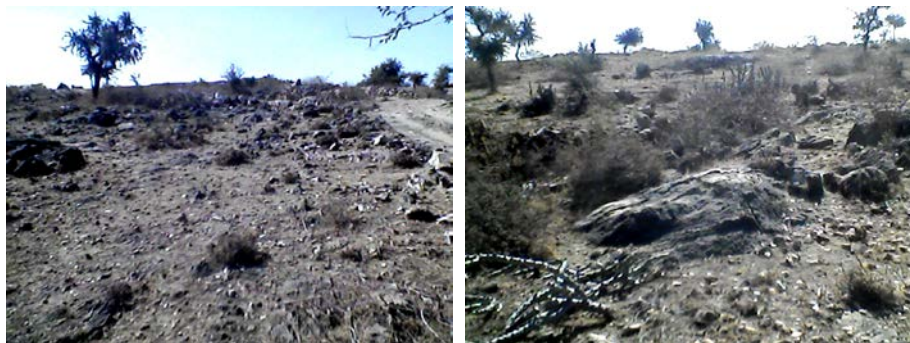
Fig. 3. View of site: See the rock exposed at ground level

The ground rises from south to north with a level variation of about 20 m from the bottom of the hillock to the top. The general ground slope varies from 8 to 11 degrees. Some nallahs are seen in the surrounding area at lower elevation. Most of the nallahs have little or no flow except during the monsoon period.

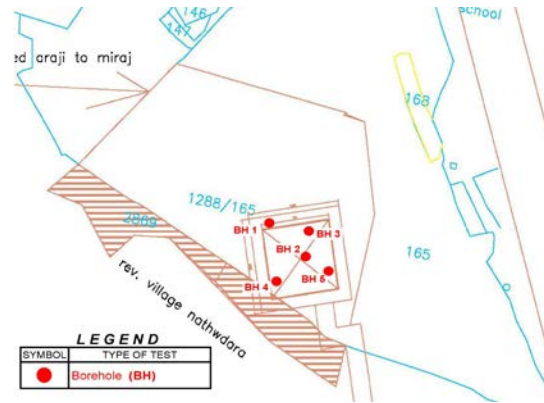
Fig. 4. Layout plan showing borehole locations

The geotechnical investigation of the site included five boreholes through the rock formation. A layout plan of the site showing the locations of the boreholes is illustrated on Fig. 4.

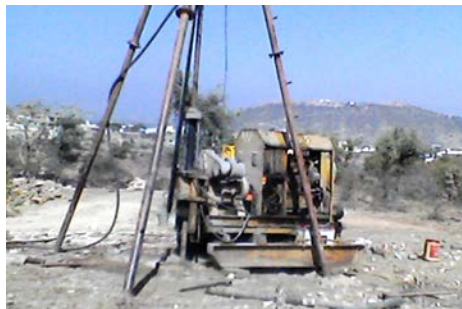
Fig. 5. Drilling in progress

Drilling was done using NX size double tube core barrel with diamond bits. Water was circulated to lubricate and cool the bit as well as to flush out the cuttings. A photograph of the drilling in progress is illustrated on Fig. 5.

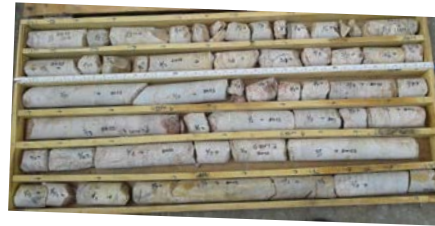
Fig. 6. Typical rock cores collected

Quartzite (rock) is encountered from ground surface to the maximum explored depth of 15 m. The rock is moderately weak to strong and moderately to slightly weathered. Typical rock cores collected are illustrated on Fig. 6.

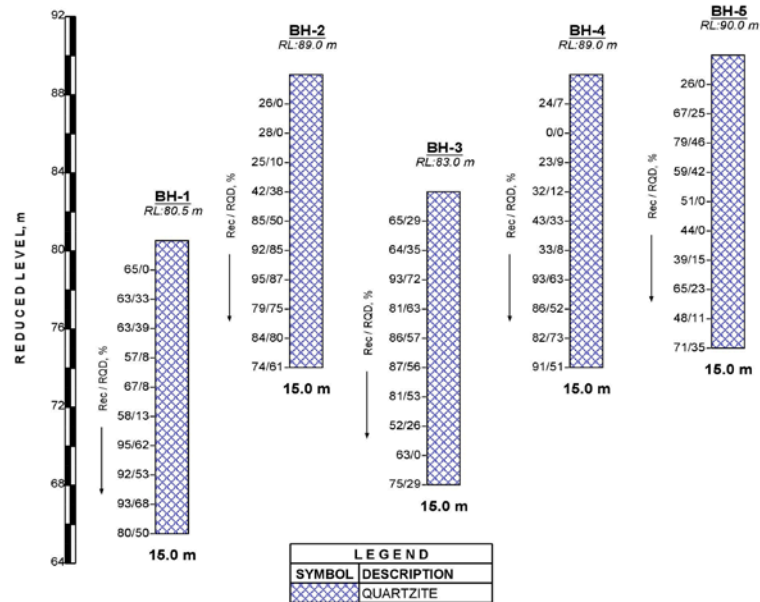
Fig. 7. Typical boreholes profile

In general, the rock at shallow depth to about 1.5-4 m depth (RL 79-84.5 m) is weak and highly fractured and has iron stains. Core recoveries in this zone range from 0 to 28 percent and the RQD value ranges from 0 to 10 percent.

Below this, the fracture frequency reduces somewhat to about RL 78 to RL 70 m. Reddish brown iron stains / veins are observed in the rock mass. Core recoveries in this zone range from 40 to 90 percent and the RQD value ranges from 33 to 50 percent. Fig. 7 presents typical boreholes drilled.

The rock below RL 78-70 m is strong and slightly weathered. The joints are widely spaced. Core recoveries in this zone range from 52 to 95 percent and the RQD value ranges from 56 to 87 percent.

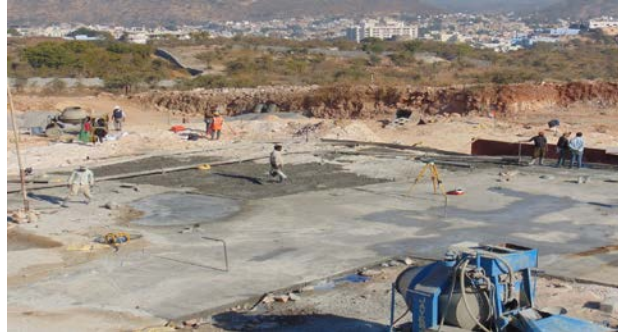
Fig. 8. Foundation level preparation

RCC raft foundation with raised pedestals to support the statue was cast at 4m depth. Bearing capacity analysis was done as per IS: 12070-1987 RA 2010 [5]. Based on assessment of RMR of the rock mass and the crushing strength of the rock, the raft was designed for a net allowable bearing pressure of 700 KN/m².

A photograph showing the foundation level prepared for raft construction is illustrated on Fig. 8. Fig. 9 shows the pedestals constructed over the raft.

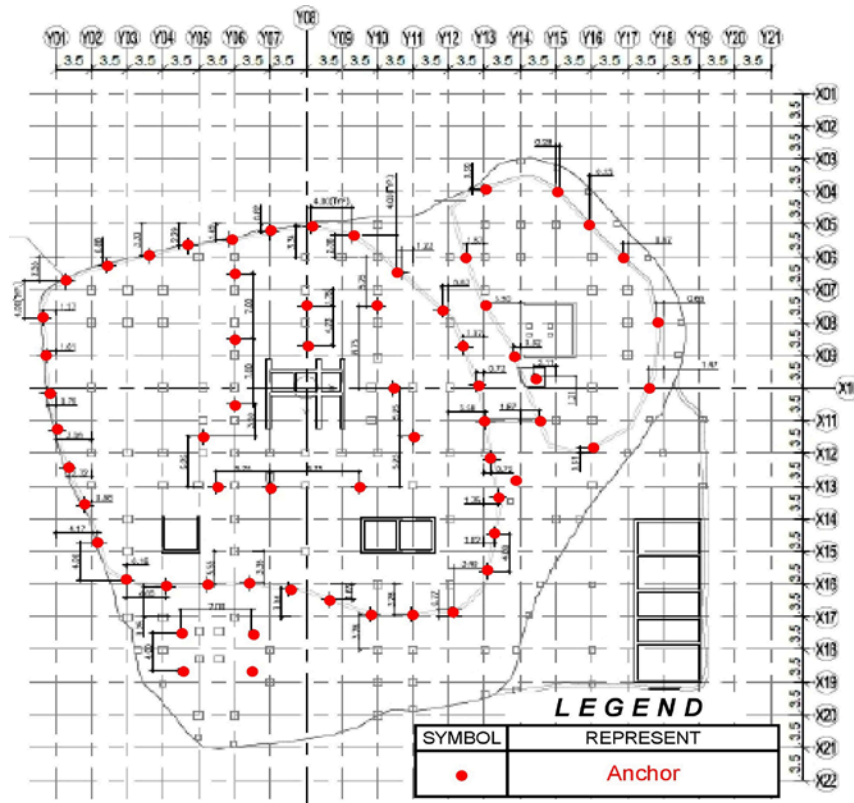
Fig. 10. Anchors Layout

Rock anchors, 8m long, embedded 7m into the rock and 1m into the raft were provided. The anchors were installed in 100mm diameter drilled holes with a Fe500 32mm TMT reinforcement bar grouted into the rock. Grouting was done using a GP-2 non-shrink grout. Anchors were designed to resist the entire lateral force due to wind and earthquake, ignoring the frictional resistance between rocks and concrete. The

anchors were placed all along the periphery of concrete wall forming the hillock at the base of statue. A drawing showing anchor layout and other details is illustrated on Fig. 10.

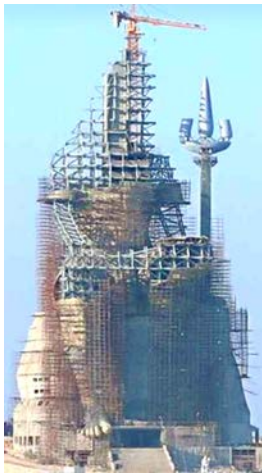
Fig. 11. Construction in progress

External skin of the statue was made through in-situ concrete pouring in specially made glass-fibre moulds. To properly support this skin and to transfer the wind forces / self-weight, special non-corrosive connections were designed. The thickness of skin shell varied from 200mm to 400mm. External geometry of statue at every 3m interval has been used to prepare structural framing by superimposing all floor plans and arranging RCC walls designed as per IS: 456-2000 [8] & steel columns which can be taken through to maximum possible heights.

Fig. 11 presents the statue under construction. Fig. 12 presents the fully constructed statue and the development around it depicting Lord Shiva majestically overseeing and benevolently ruling over the surroundings.
