Quality Assurance of Large Diameter Base Grouted Bored Piles for a Railway Bridge in Bangladesh

Abstract—Base-grouted piles of 1500 to 2500 mm diameter bored cast-in-situ piles were installed for a railway bridge over River Rupsa in Bangladesh. To ensure that the piles are safe to support the design loads, a comprehensive quality assurance program was implemented. This included conducting high-strain dynamic load tests and ultrasonic cross-hole sonic logging. The paper presents use of these tests to ensure that the piles are of acceptable quality and can support the loads safely. Typical results of selected tests are presented demonstrate the reliability of the tests conducted.

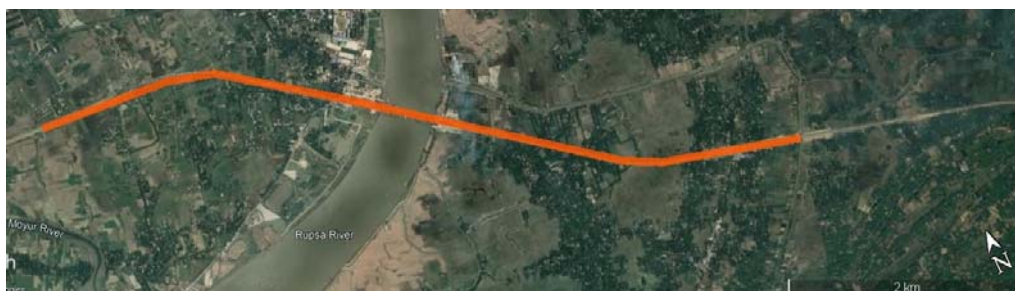
Fig. 2. Alignment of bridge across River Rupsa

The bridge has 69 spans 32.45 m long on the Khulna side approach, 7 spans 102.4 m long for the main bridge in the river portion and 67 spans 32.45 m long on the Mongla side approach. Fig. 2 presents a satellite image showing the alignment of the bridge.

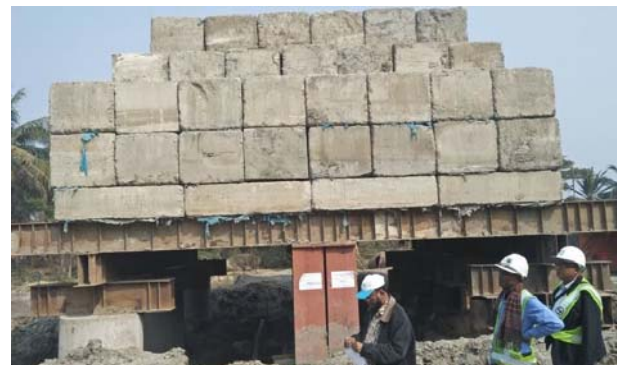
Fig. 5. Static pile load test in progress

Two vertical initial load tests (installed near Pier P-63) were performed on 1500-mm diameter piles, one of length 40 m and the second of length 52 m. The safe loads interpreted from the tests were 389 T for the 40 m long pile and 469 T for the 52-m long pile. Fig. 5 presents a photograph of a pile load test in progress.

Both piles fell short of the required safe loads with large displacement under the design load. The low capacity of the piles is probably due to poor end bearing, probably due to slush / muck at the bottom of the pile-bore. Safe capacity of long pile is less than the design capacity primarily due to insufficient bottom cleaning and presence bentonite slurry mud and soft material after caving. This was confirmed by low-strain pile integrity test that suggested a very poor toe response.

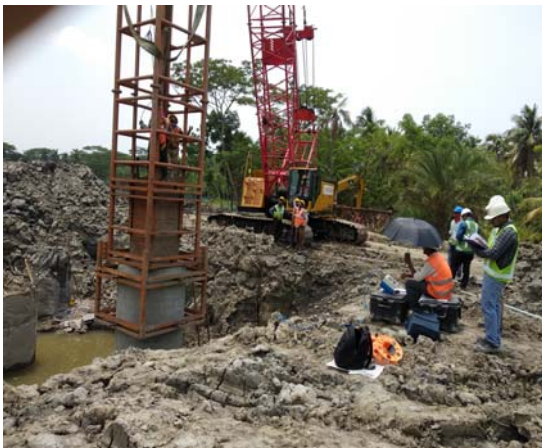
Fig. 6. HSDLT test in progress

An 8.5 MT hammer was used to perform the test. Drop heights ranging from 0.5 to 2 m were used. A typical arrangement for the test is illustrated on Fig. 6.

The tests were performed on the 1500 mm diameter piles installed along the approaches on either side of the main bridge across the river.

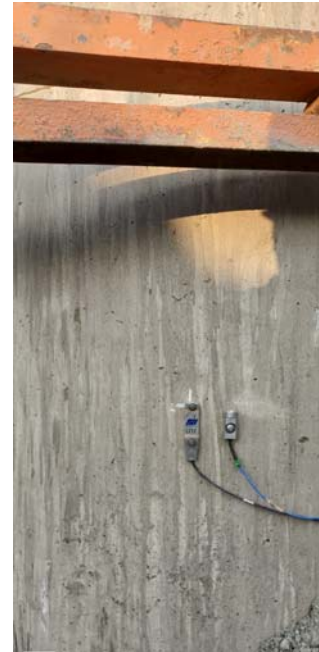
Fig. 7. Close-up view of accelerometer and strain gauge installed on a 1500 mm diameter pile

Four strain gauges and two accelerometers were attached to the pile just below the pile head. They were mounted on the opposite sides of the pile to cancel the bending effects during strike of the hammer.

A close-up of an accelerometer and strain gauge installed on the pile is illustrated on Plate 7.

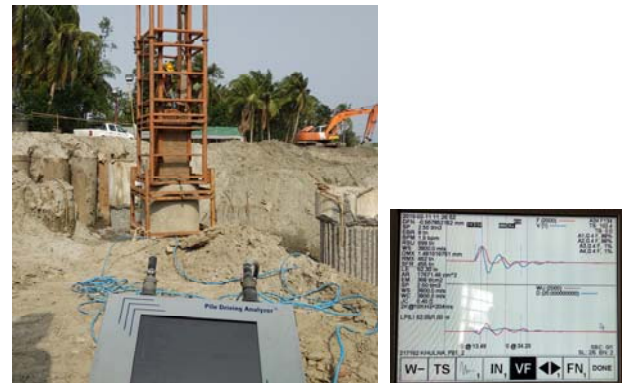
Fig. 8. Data acquisition using PDA

On each pier, one pile in the pile group (of 6-8 piles) were tested in accordance with ASTM D 4945-12 [6]. The signals of the strain and acceleration were processed by the PDA. Data acquisition using the Pile Driving Analyzer is shown on Fig. 8.

The PDA measures the total (static and dynamic) resistance acting on the pile. Selected PDA field records of force and velocity data for a blow delivered to the pile is analyzed using CAPWAP software. This involves applying the measured pile-top velocity-time record to the top of a lumped-mass and spring in a wave equation pile-model. After CAPWAP analysis is done, the complete pile and soil model is available for static analysis. This is analogous to a static load test and is referred to as a “simulated load test”.

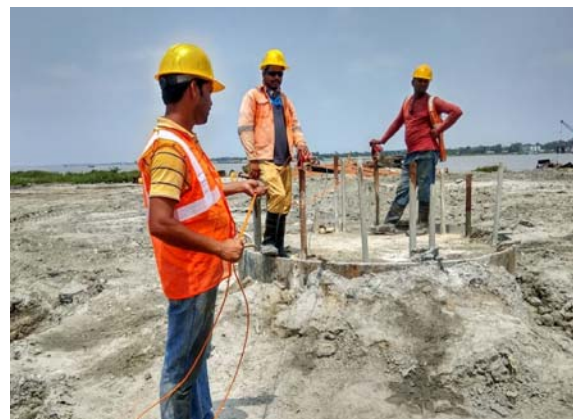
Fig. 10. Pipes cast in pile for CSL test

The test involved casting four to six PVC pipes in the pile. For the 2500 mm diameter piles of the main bridge, six access pipes were cast in the piles. Two ultrasonic transducers of which one a transmitter and the other a receiver are lowered to the bottom of the water-filled tubes, leveled. The transducers are lifted in unison in their respective access tube(s) to test the pile shaft from bottom to top. The transmitter probe generates ultrasonic pulses at frequent and regular intervals as the probes move upward.

Fig. 10 illustrates pipes cast in the pile and probe being lowered into the pile for testing. Fig. 11 shows the data acquisition for cross-hole sonic logging in progress.

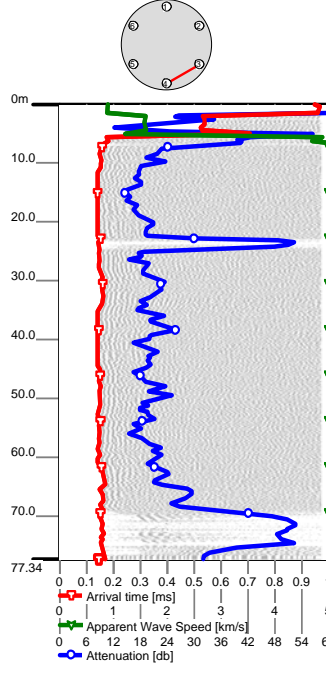
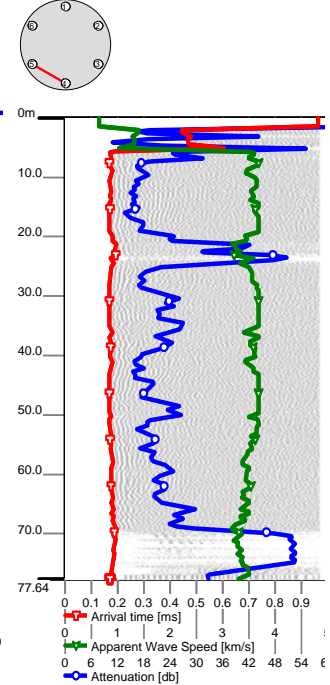
Fig. 12. Typical CSL output for Pile P72/1

Typical results of some selected piles are summarized in Table II. Fig. 12 presents typical output of cross-hole sonic logging from Pile 72/1 and the interpretations from the test results.

P72/1 Data acquisition between Pipes: 1-2
Interpreted Depth: 77.29 m

P72/1 Points 1-2: Sound section below 5m. from top

P72/1 Data acquisition between Pipes: 2-3
Interpreted Depth: 77.59 m

P72/1 Points 2-3: Sound section below 5m. from top

P72/1 Data acquisition between Pipes: 3-4
Interpreted Depth: 77.34 m

P72/1/3-4: Sound section below 5m. from top

P72/1 Data acquisition between Pipes: 1-6
Interpreted Depth: 77.94 m

P72/1/4-5: Sound section below 5m. from top

The ultrasonic cross-hole ultrasonic logging for the 2500 mm diameter piles confirmed that the piles are of fairly uniform quality.
