FORENSIC EVALUATION OF BORED PILES FOR A FACTORY PROJECT AT JHAJJAR

Ravi Sundaram, Cengrs Geotechnica Pvt. Ltd, Noida, Uttar Pradesh, India, ravi@cengrs.com,
Sorabh Gupta, Cengrs Geotechnica Pvt. Ltd, Noida, Uttar Pradesh, India, sorabh@cengrs.com,
Sanjay Gupta, Cengrs Geotechnica Pvt. Ltd, Noida, Uttar Pradesh, India, sanjay@cengrs.com

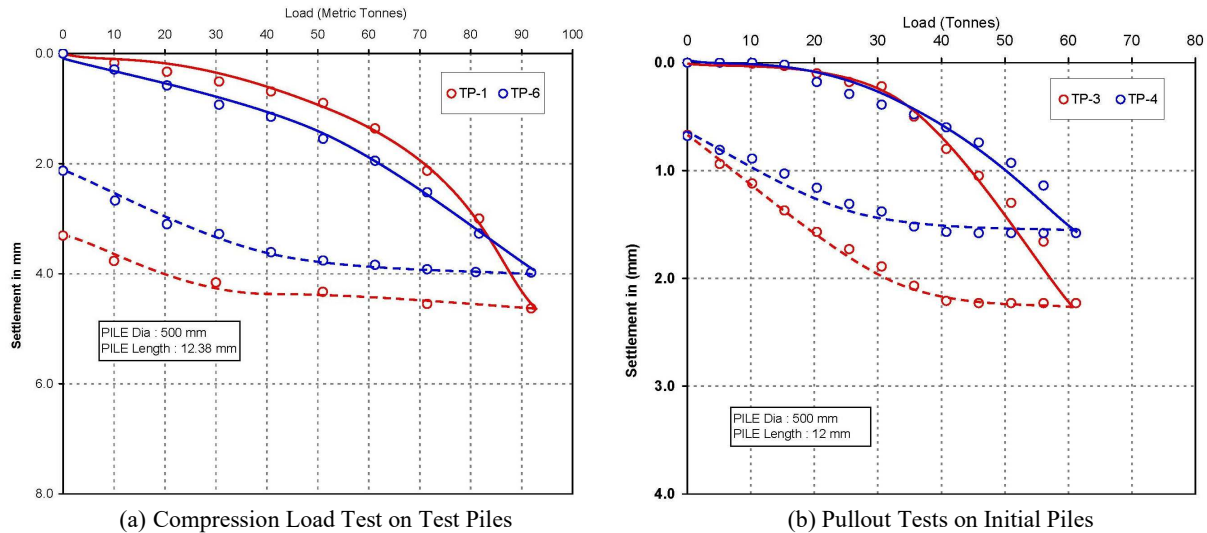
Fig. 4. Load-Settlement curves - Typical tests on initial piles

Initial pile load tests were conducted on 500 mm diameter 12.4 m long test piles. The piles were designed for a compression load of 35 tonnes and pullout capacity of 23 tonnes. All piles were safe under the design load. Under the maximum applied load of 2.5 times the design load, the maximum displacement was less than 5 mm. Typical compression load and pullout test results are presented on Fig. 4.

Since the test piles passed under compression, pullout and lateral load tests, the contractor claimed that all the piles are deemed to be safe. However, while a few piles were having capacity higher than the design value, detailed evaluation proved that quality of pile construction needs to be evaluated to confirm that all piles are of uniform and acceptable quality.

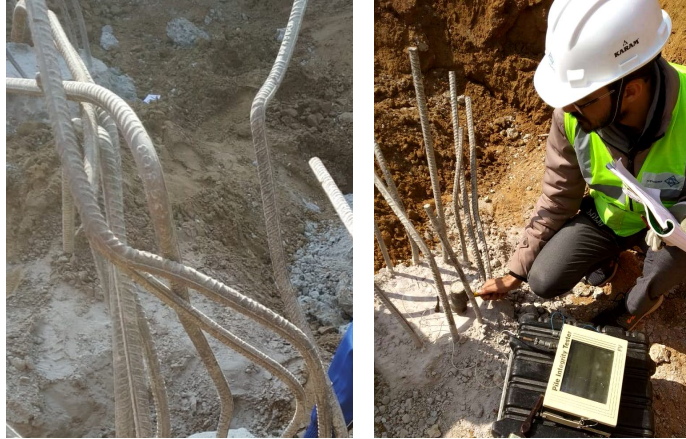
Fig. 5. Pile integrity tests in progress

To assess the pile quality, PIT was done on all the piles installed at site. To perform the test, the pile top surface is prepared in order to form a clean, sound and hard concrete for testing. Fig. 5 presents photographs of the test being done on two typical piles.

The accelerometer is fixed to the top of the pile using a special wax. Signal enhancement by repeated hammer blows on the pile head helped to minimize effects of noise or other disturbances (see PIT Collector User’s Manual, 2005). Some typical PIT plots are presented on Fig. 6. Typical results are summarized in Table 1.

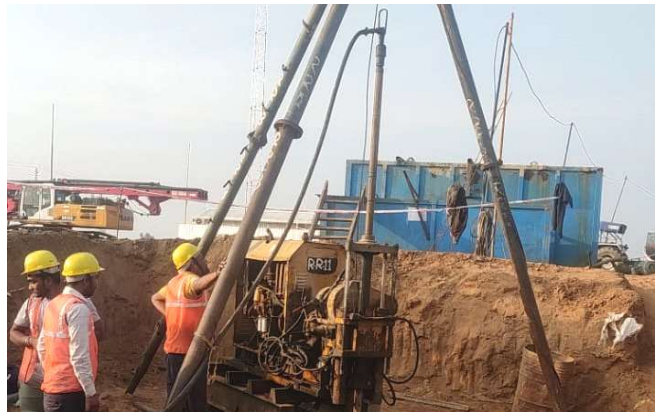
Fig. 7. Pile Coring in Progress

A few selected test piles were evaluated further by coring through the piles. Experience has shown that coring through the concrete (Sanjay Gupta et al, 2017) can effectively evaluate the concrete quality and depth and also assess the condition of the pile toe. Fig. 7 illustrates pile coring in progress.

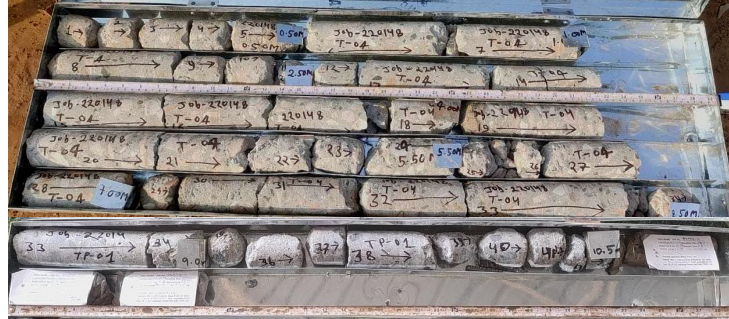
Fig. 8. Pile Coring Results: TP-4

Typical concrete cores collected from TP-4 are illustrated graphically on Fig. 8. Fig. 9 summarizes the recovery and RQD values together with the interpreted pile profile from PIT results for two typical piles. Table 2 presents the interpretation based on the concrete coring through the piles.

Note: Soil encountered below 10.5 m depth

Pile No.	Design Pile Length, m	Pile Length from PIT, m	Actual Pile Length determined from coring, m	Observations and Interpretations
TP-1	12.37	12.3	9.75	The actual length of the pile is less than the anticipated length of 12.37 m. Necking observed at 7.1 m depth.
TP-4	12.37	9.0 - 10.0*	9.0	Soil was met below 9 m depth. The actual length of the pile is less than the anticipated length. Pile integrity results suggested pile length of 9 to 10 m.
TP-6	12.37	12.37	9.0 – 10.5	The actual length of the pile is less than the anticipated length of 12.37 m. Also, steel reinforcement was encountered at about 6.0 to 9.0 m depth.

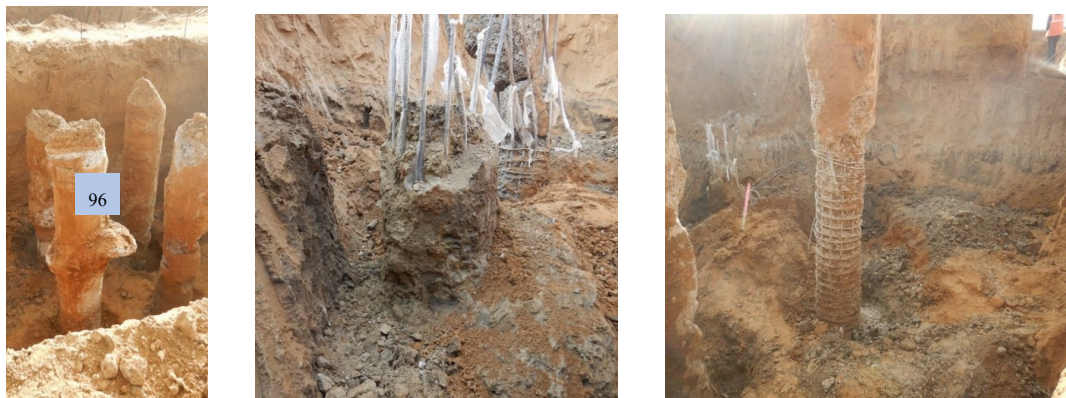
Fig. 11. Condition of some of the exposed piles

Photographs of some exposed piles shown on Fig. 11 confirm that the pile quality at shallow depth leaves much to be desired. Bulging, poor concrete quality, exposed reinforcement, lack of concrete cover, etc. were observed in many cases.

Pile 96 Pile 108 Pile 113
 Bulging at shallow depth in Pile 96 Poor concrete quality in Pile 108 Exposed reinforcement in Pile 113
