Landslide at Govindghat – Investigation and stabilization measures

Abstract. A cloudburst and flash flood in June 2013 in the state of Uttarakhand, India caused landslide at Govindghat located along a major highway. Large boulders in soil matrix were encountered in the area. Water seeping through the open pores between the boulders and erosion of the soil were the major causes of the slope-failure. Erosion of the accumulated debris on the valley side during periods of high discharge in the area also added to the instability. The stabilization measures adopted include a secured drapery of rock anchors and steel mesh on the hill side, nailed gabions at road level, reinforced soil wall to ensure the desired road width and river-side gabion wall for erosion protection.

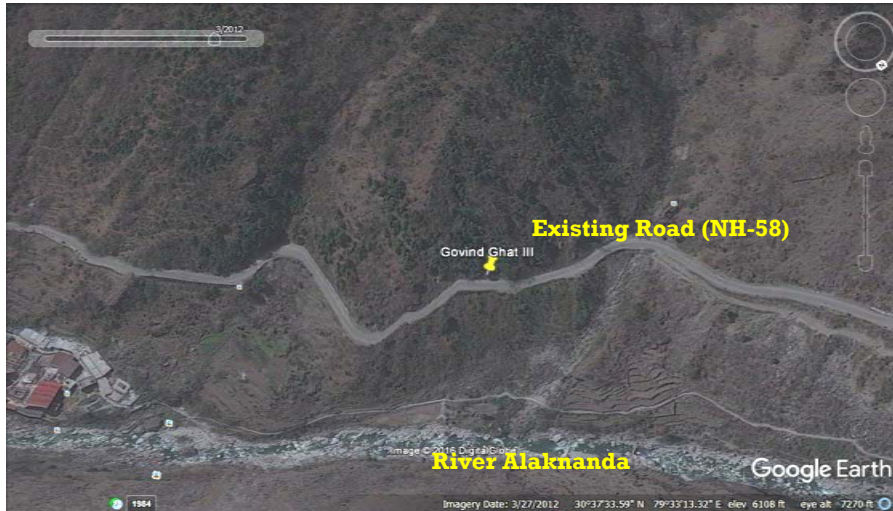
A satellite image in 2012 shows no landslide and overall stable conditions along the highway with vegetation on the hill-slopes (See Fig.1). Satellite image of 2014 illustrated in Fig. 2 shows a major landslide along the highway. Since this is the third landslide in the vicinity of Govindghat town, it is identified as Govindghat III.

Fig. 1. Satellite Image – 2014 shows no landslide in the area

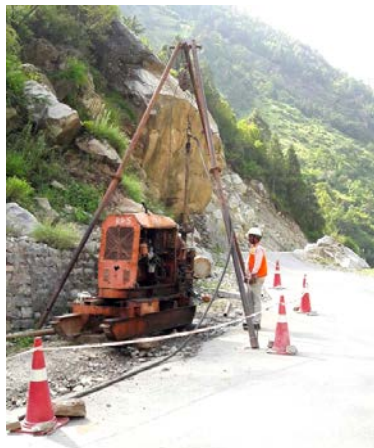
Fig. 4. Borehole drilling in progress

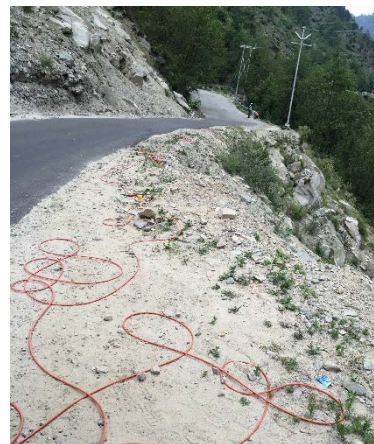
Fig. 5. Seismic refraction test in progress

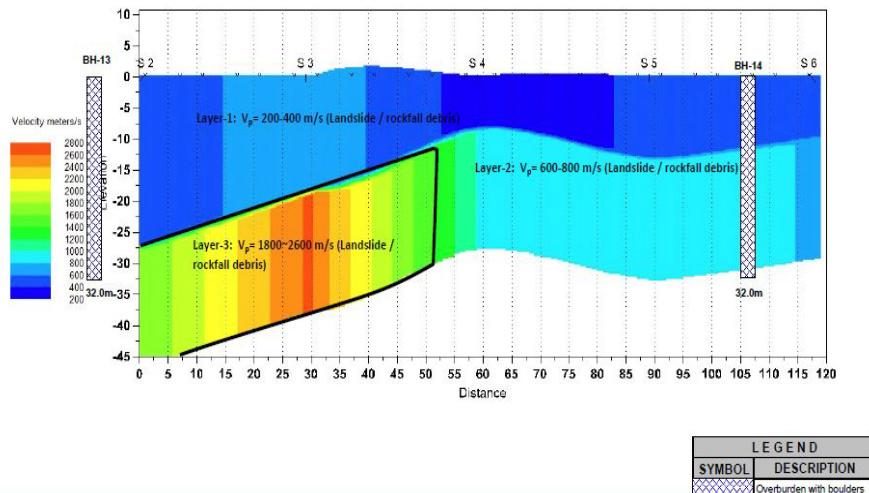
The study indicated the presence of large size boulders and cobbles in a soil matrix to substantial depth, probably extending to the riverbed. Most of it was landslide debris material. The higher recovery and RQD values are due to the large size of the boulders. Fig. 6 presents the seismic profile along with the borehole data superimposed on it.

Fig. 6. Geophysical profile together with borehole data

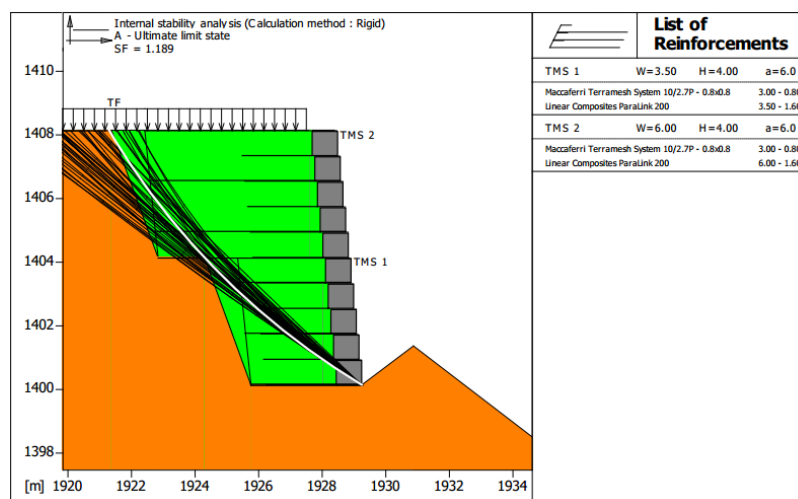
Fig. 11. Slope stability analysis of 8m high reinforced soil wall

1. For retention of proposed 12-m wide road, reinforced soil wall of 8 m maximum height has been constructed. The wall is designed for the traffic load and very high seismic loads (as per BS 8006 Part-1 [3] and for seismic loading condition, FHWA-NHI-10-024 [4]). The stability analysis was performed using inhouse built software for both static and seismic conditions. This software allows the user to conduct the stability checks using the Limit Equilibrium Method and to do checks of different possible failure mechanism in heterogeneous strata layers with all possible load combinations described in BS 8006.

A typical of software analysis is presented in Fig. 11 and the summary of factor of safety (FoS) is given in Table-1.

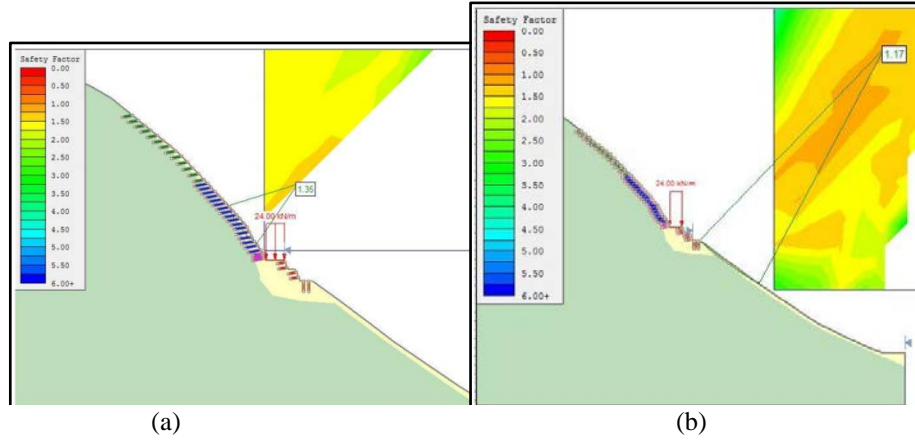
Fig. 12. Slide analysis results (a) for hill side (static) FOS = 1.35 (b) for valley side (seismic) FOS = 1.17

2. For protecting the toe on hill side, nailed gabion wall of 3m height was provided for entire stretch. By providing nailed gabion, cutting into the hill is reduced as compared to gabion retaining wall, thereby minimizing disturbance to the in-situ strata.

A typical software analysis output is shown in Fig. 12 and the summary of factor of safety (FoS) is given in Table-2.

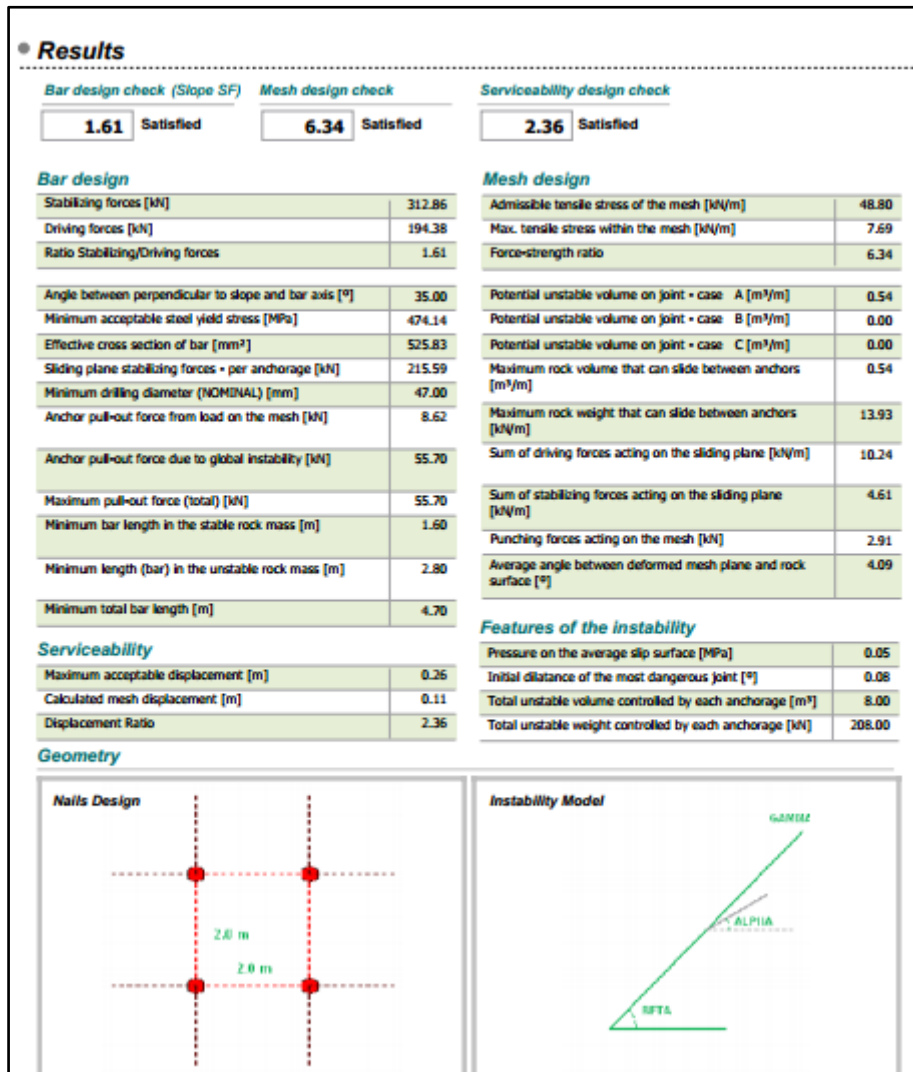
Fig. 13. Analysis of secured drapery system

3. On the hill-side, secured drapery consisting of rock anchors with steel mesh was used to secure the large boulders (designed as per Indian Roads Congress IRCHRB Special Report 23 [5]) all along the road in the landslide zone. For the design of secured drapery, inhouse built software was used. The analysis for the design of for hill side slope protection and rock-fall mitigation was performed using this software, a limit equilibrium approach for the design of secured drapery. A typical output file of the analysis can be seen in Fig.13. The summary of factor of safety used in the analysis for seismic conditions is given in Table 3. Suitable bioengineering measures are being implemented to enhance the stability of the area.

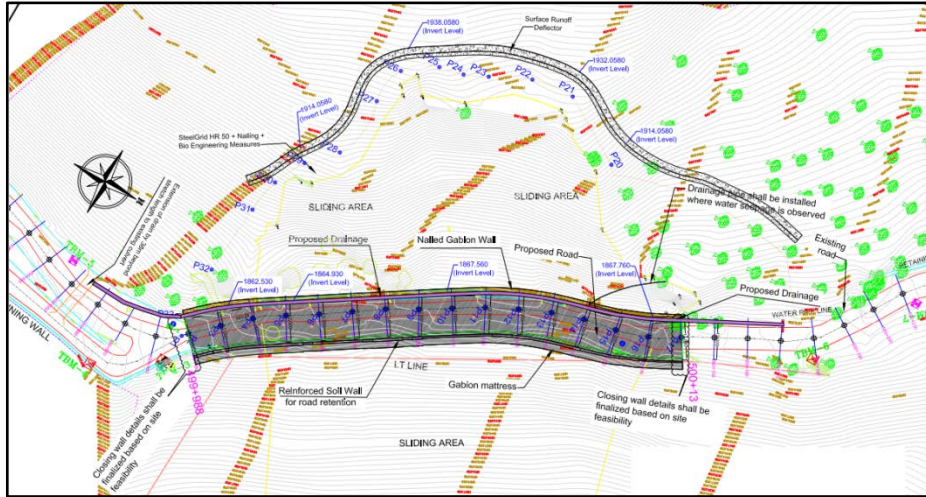
Fig. 14. Drainage plan showing mitigation measures on hill side of the road

4. Runoff water was channelized by providing adequate drainage measures including surface run-off deflector and roadside drain which discharges the water collected into a nearby culvert as shown in Fig. 14 (designed as per IRC SP 42 [6]). Fig. 15 illustrates the scheme adopted. Rainfall intensity was calculated as per IRC:SP013 and was measured as 14.58 cm/hr. Catchment area delineation was done in Arc-GIS software and was calculated as 5.1 hectare. Design discharge from catchment was calculated as per IRC SP 42 and was come out as 1.66 m³/sec. Manning's equation was used to calculate allowable discharge for roadside drains and was come out as 2.71m³/sec with the factor of safety of 1.63.

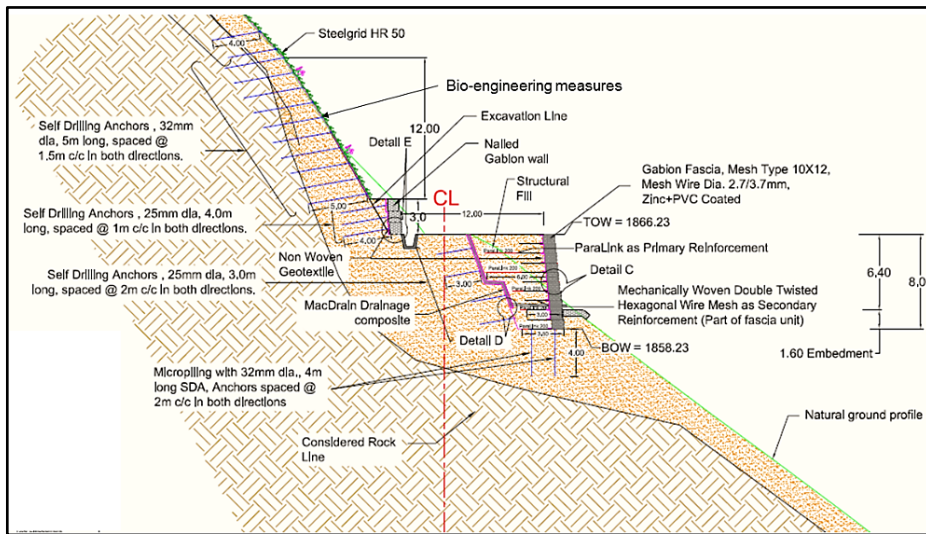
Fig. 15. Reinforced soil wall with secured drapery on hill side and nailed gabions to arrest rockfall (schematic sketch, not to scale)

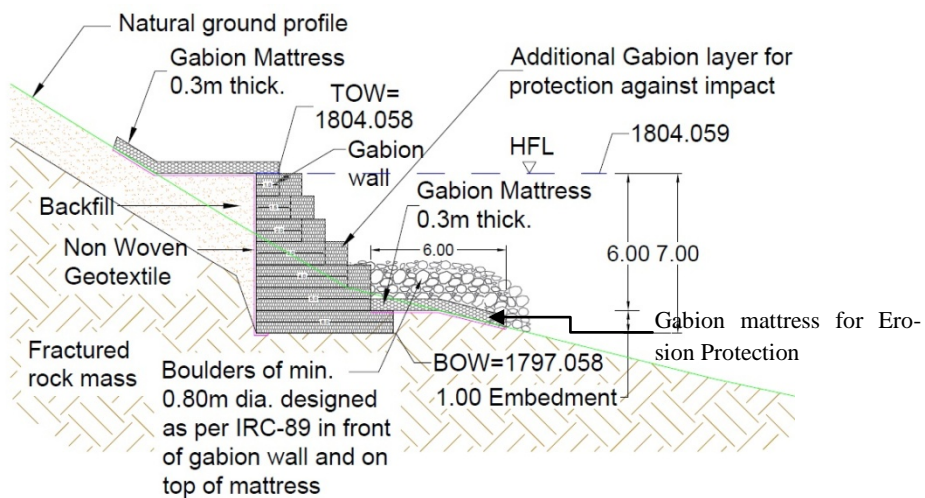
Fig. 16. River-side Gabion Wall for bank protection(schematic sketch, not to scale) Note:
HFL: High Flood Level (m) TOW: Level of Top of Wall (m) BOW: Level of Bottom of Wall (for 1 m embedment)

5. For protecting the toe exposed to the river, a gabion toe-wall has been provided for the whole 150m stretch along with the gabion mattress as launching apron to protect the exposed toe and reduce erosion as per IRC 89 [7]. The mattress was covered with big boulders (min. 800 mm size). The gabion mattress act as a launching apron and boulders provided added protection against large boulder impacts to the structure flowing along the river during floods. The protection has been done to 1

m above the high flood level. Fig. 16 illustrates the details. The stability analysis of gabion toe wall was performed using inhouse built software. The stability of gabion toe wall i. e. both internal and external stabilities were checked using limit equilibrium method and the global stability was checked using theories of Bishop (1955)[8]. & Jambu (1956)[9]. External stability of each individual gabion wall against sliding, overturning and foundation bearing pressures were checked and verified. Internal stability of gabion layers was checked by taking apparent cohesion and apparent angle of internal friction between gabion layers. A typical output of software analysis is presented in Fig. 17 and the summary of Factor of Safety (FoS) is given in Table 4 and Table 5.

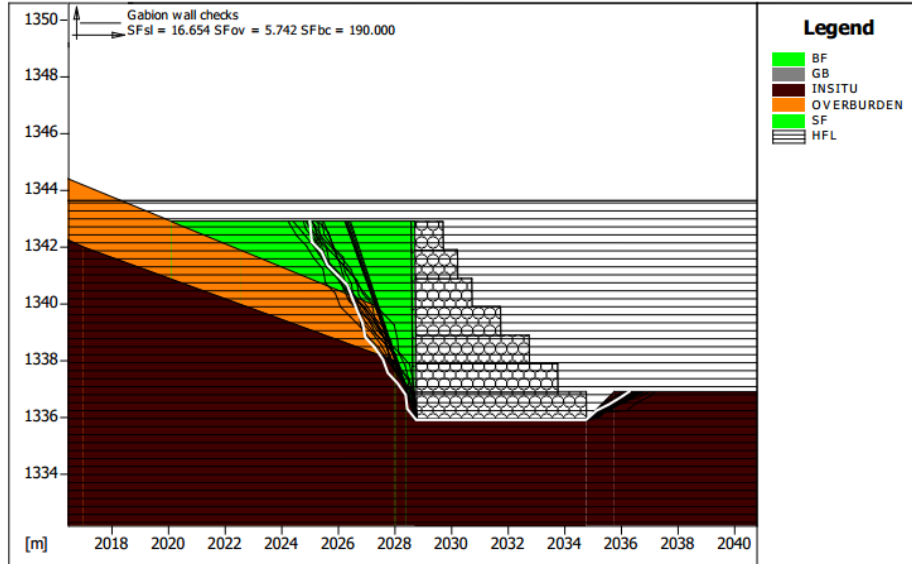
Fig. 17. Slope stability analysis of 7m high gabion toe wall
